**D&D Best Practices
Demolition of a Research Facility
Building 431**

**William L. Collins, P.E.
SAT Project Manager
Lawrence Livermore National Laboratory**

**EFCOG – Infrastructure Management Working Group
October 4-6, 2005**

UCRL-PROC-215810

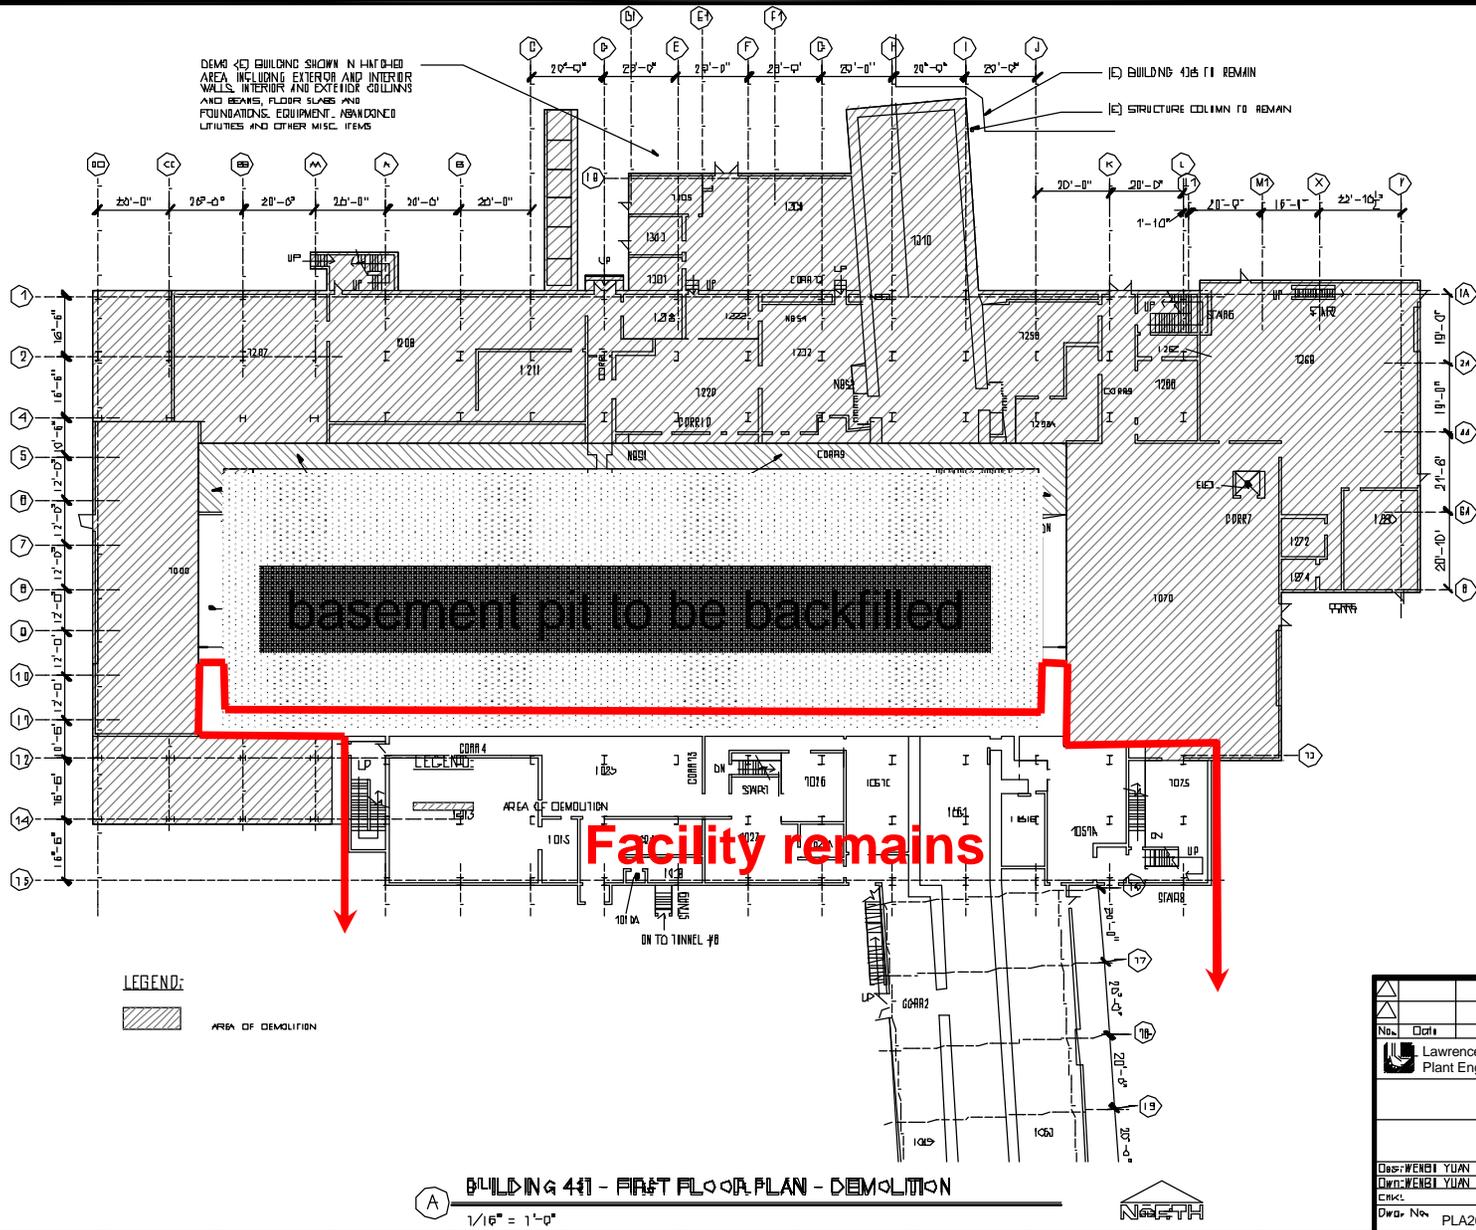
No.	Date	Revision	Drawn	Checked	By	Scale
1						
Lawrence Livermore National Laboratory Plant Engineering, Livermore, CA 94550						
BUILDING 431 DEMOLITION						
FIRST FLOOR DEMOLITION PLAN						
Des:	WENGLI YUAN	07/31/03	Scale:			
Drawn:	WENGLI YUAN	09/13/03	Permit:			
Check:			Scale:			
Draw No:	PLA2003-0431-0003D	Sheet No:	A-1

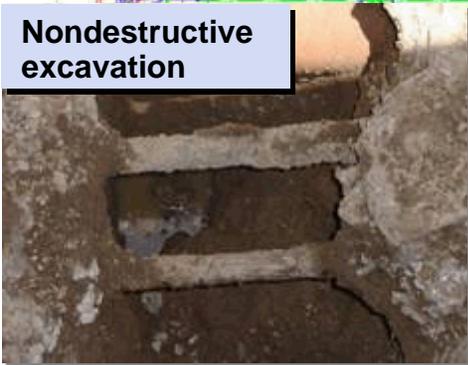
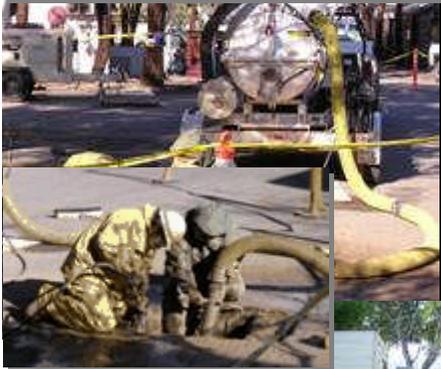
Nondestructive excavation

GPR/GPS and Acoustic Listening Device

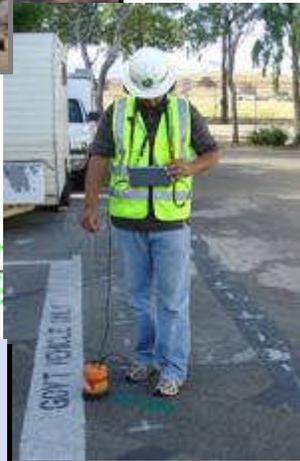
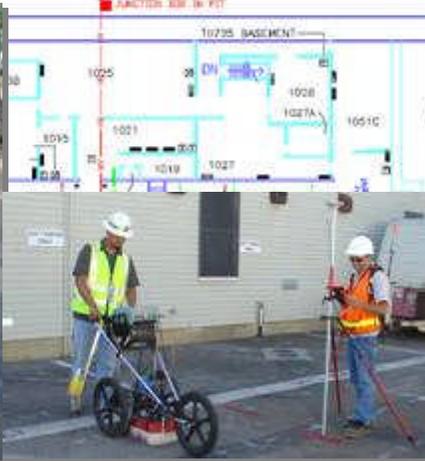
Radio frequency device traces line

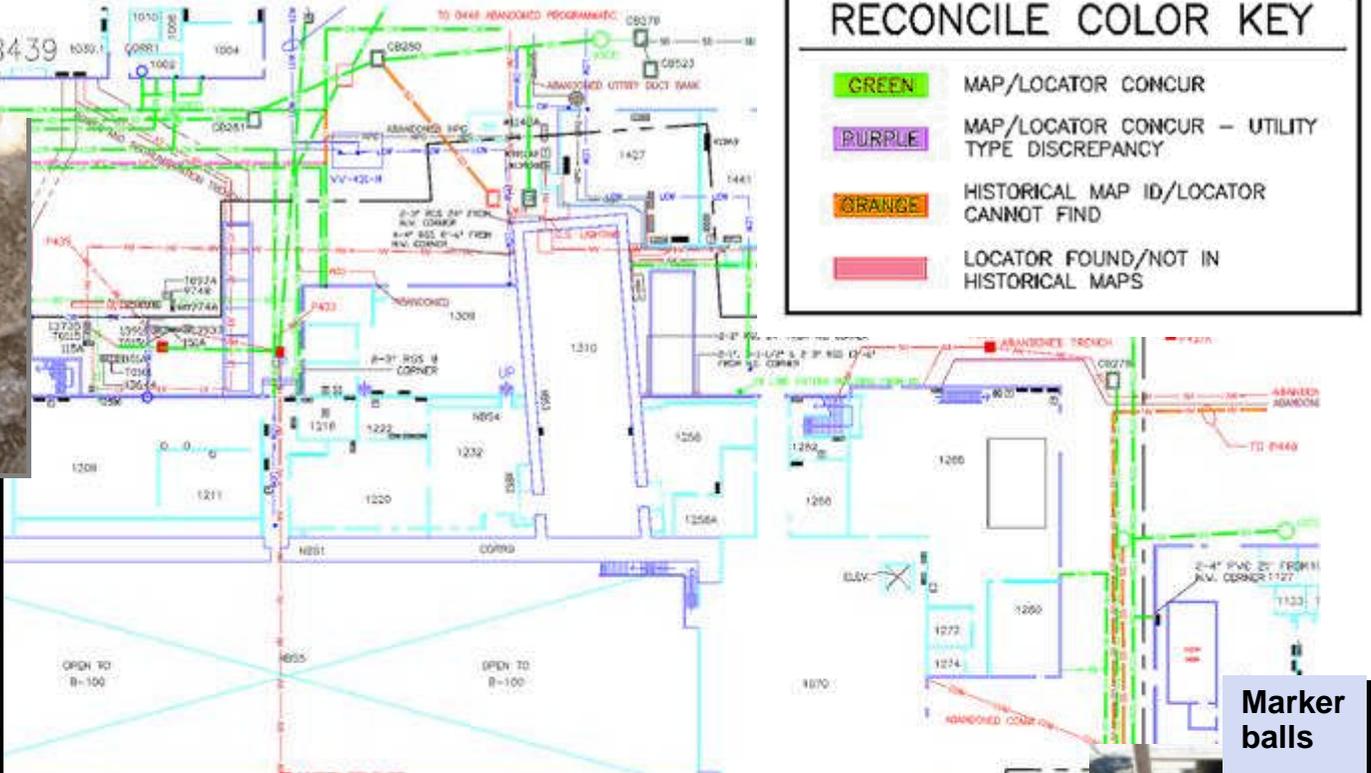
RECONCILE COLOR KEY	
GREEN	MAP/LOCATOR CONCUR
PURPLE	MAP/LOCATOR CONCUR - UTILITY TYPE DISCREPANCY
ORANGE	HISTORICAL MAP ID/LOCATOR CANNOT FIND
PINK	LOCATOR FOUND/NOT IN HISTORICAL MAPS

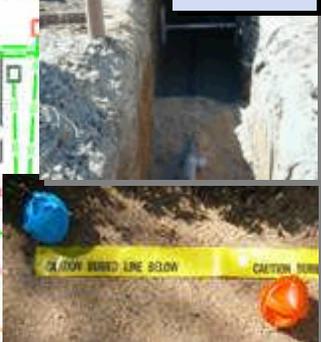
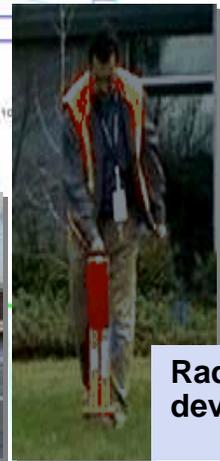
Marker balls

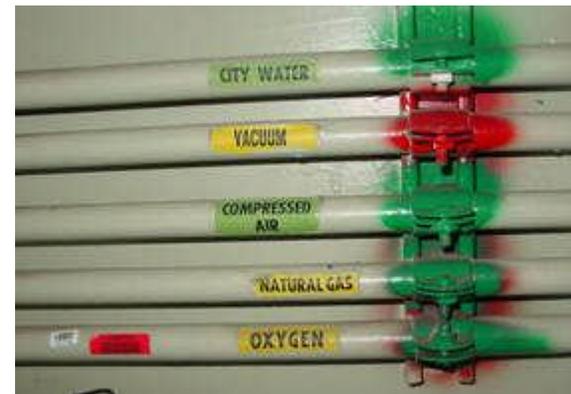
Solution: SAT uses a color code to identify the status of all Structures, Sub-systems, and Components (SSCs) during decommissioning through disposition.

Red: Known hazard exists on or inside a SSC.

Yellow: SSCs denoting caution.

Blue: Controlled disposal to the Municipal Landfill

Green: Free release - no issue.

Black: Editorials and instructions

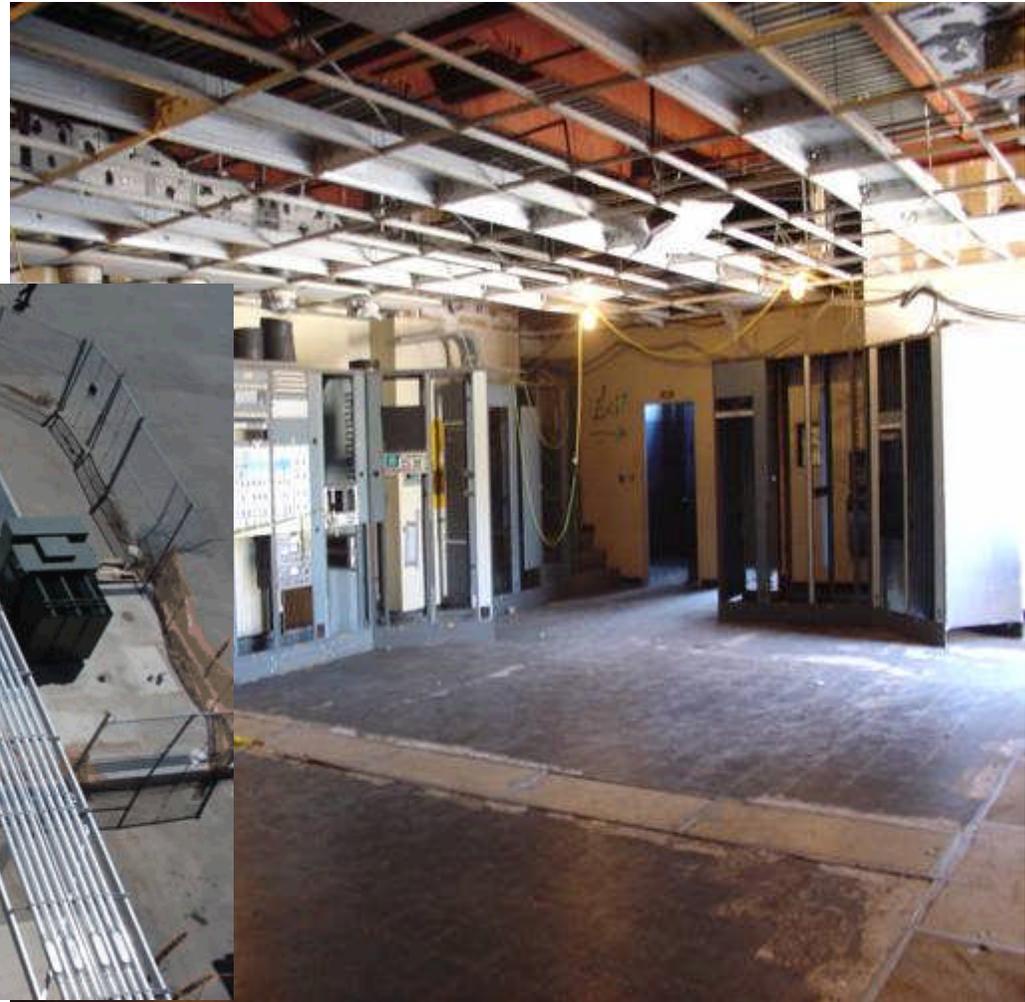
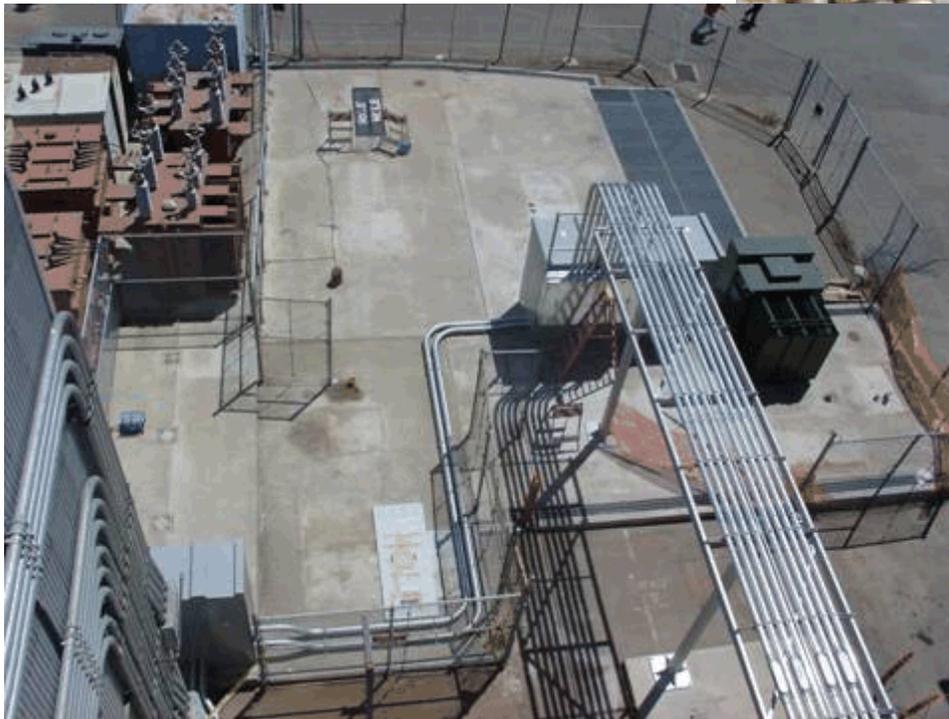
- **Completed**
 - Deactivation and reroute of utilities
 - Interior abatement
 - Demolition of 8,000 SF

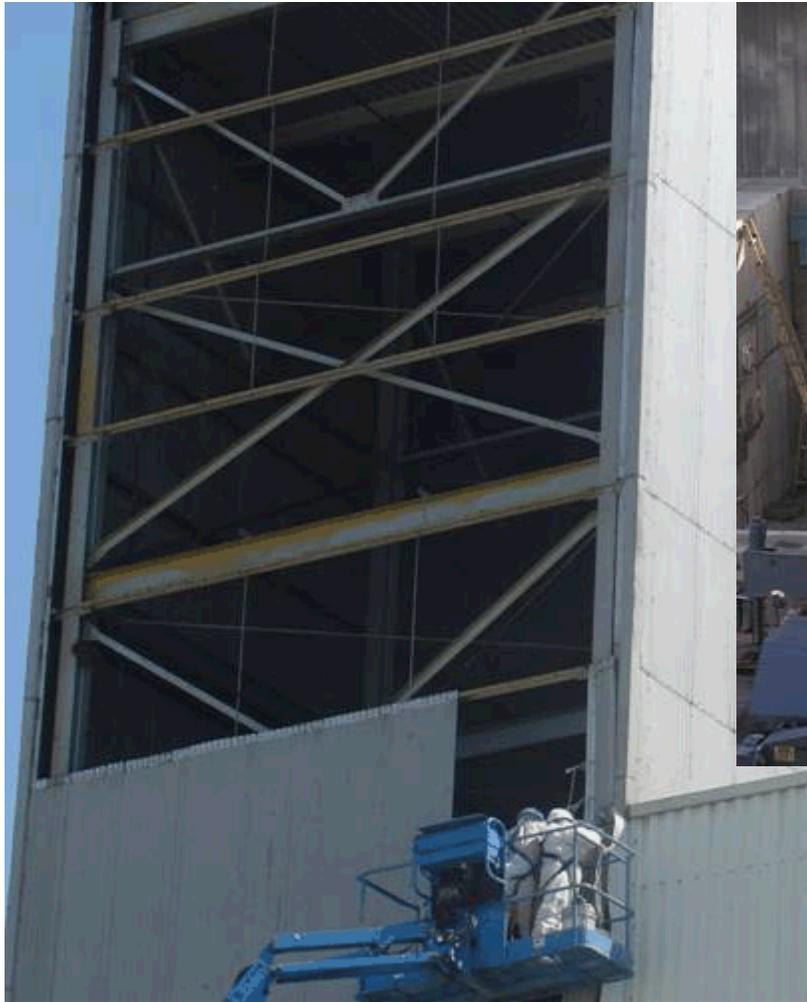
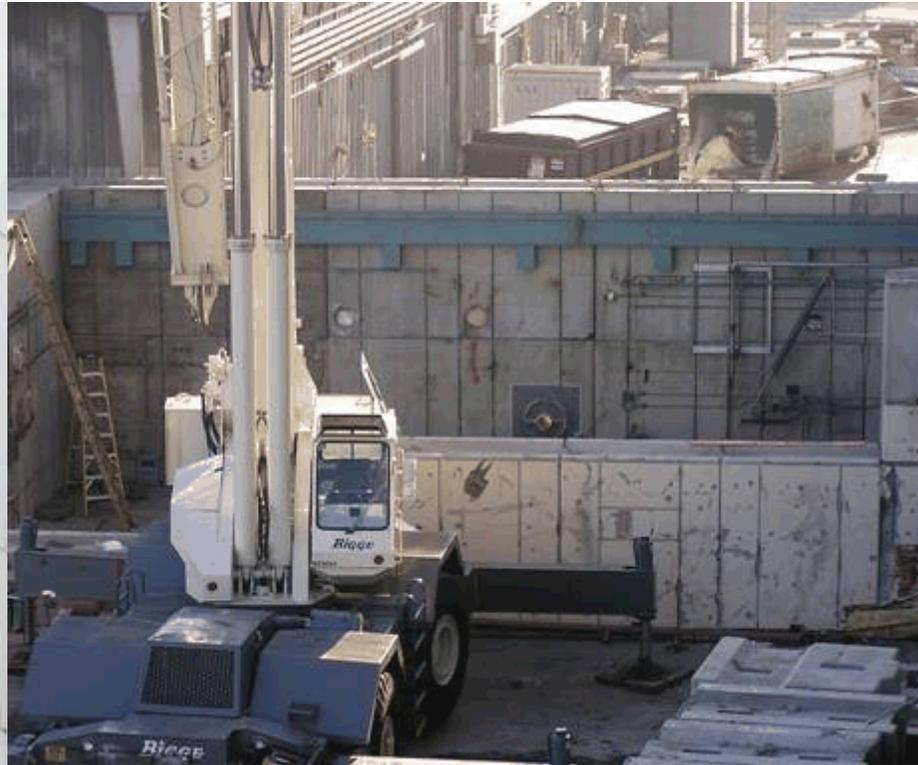
- Working
 - Abatement/removal of Galbestos siding
 - Structural demo
 - Specs for Restoration design-build
